# Manhole Inspection Summary

Manhole # S19A\_\_012MH

Insp Date: **10/24/07 12:28 PM**

**Location** Address: **2012 RAYNER-HARLEM**

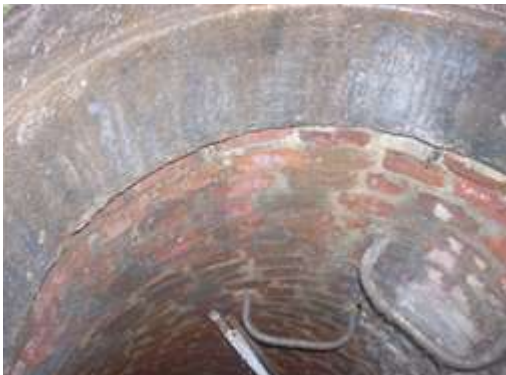
Defect 2

Infiltration: ☐ None ☒ **Joint** ☐ Cracks ☐ Mortar ☐ Roots ☐ Wall

INFILTRATION OF THE CORBEL JOINT

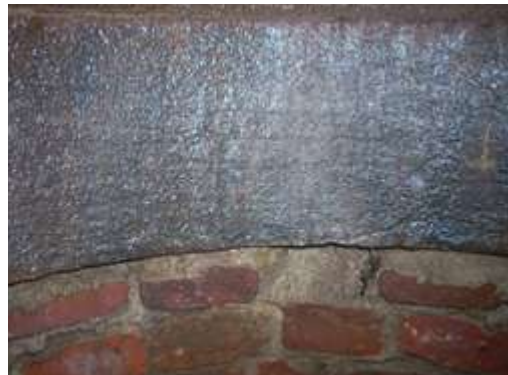
Defect 1

Condition: ☐ Sound ☐ Cracked ☐ Root Intrusion ☐ Loose Brick ☒ **Deteriorated**

DETERIORATED CORBEL

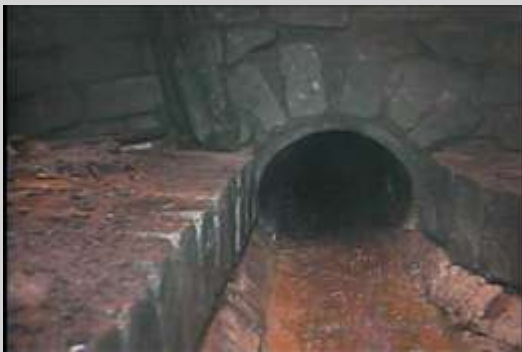
12 O'Clock Outflow

Pipe Height: **8.4** (in.) Rod and Bar (Angled)  
Pipe Material: **Clay** ☐ Pipe Lined  
Invert Depth: **7.71** (ft.) Flow Characteristics: **Slow**  
Deposits: ☒ None ☐ Mud ☐ Sludge ☐ Debris ☐ Grease  
Silt Depth: (in.) Deposits Extent:  
Infiltration: **None** Pipe Seal Cond: **Sound**

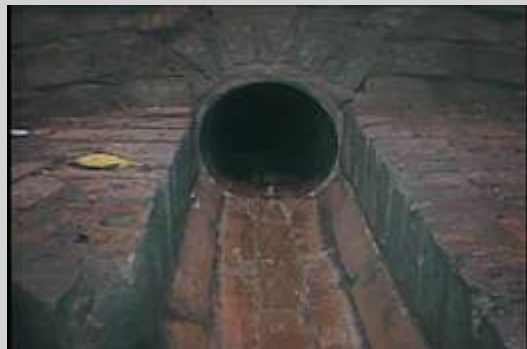
6 O'Clock Inflow

Infiltration: **None** Pipe Seal Cond: **Sound**
